New LN₂ Heat Exchanger for HEUB Helium Refrigerator

2/11/04 K. C.

Photos on HEUB E-1 LN2 Heat Exchanger Removal And Replacement

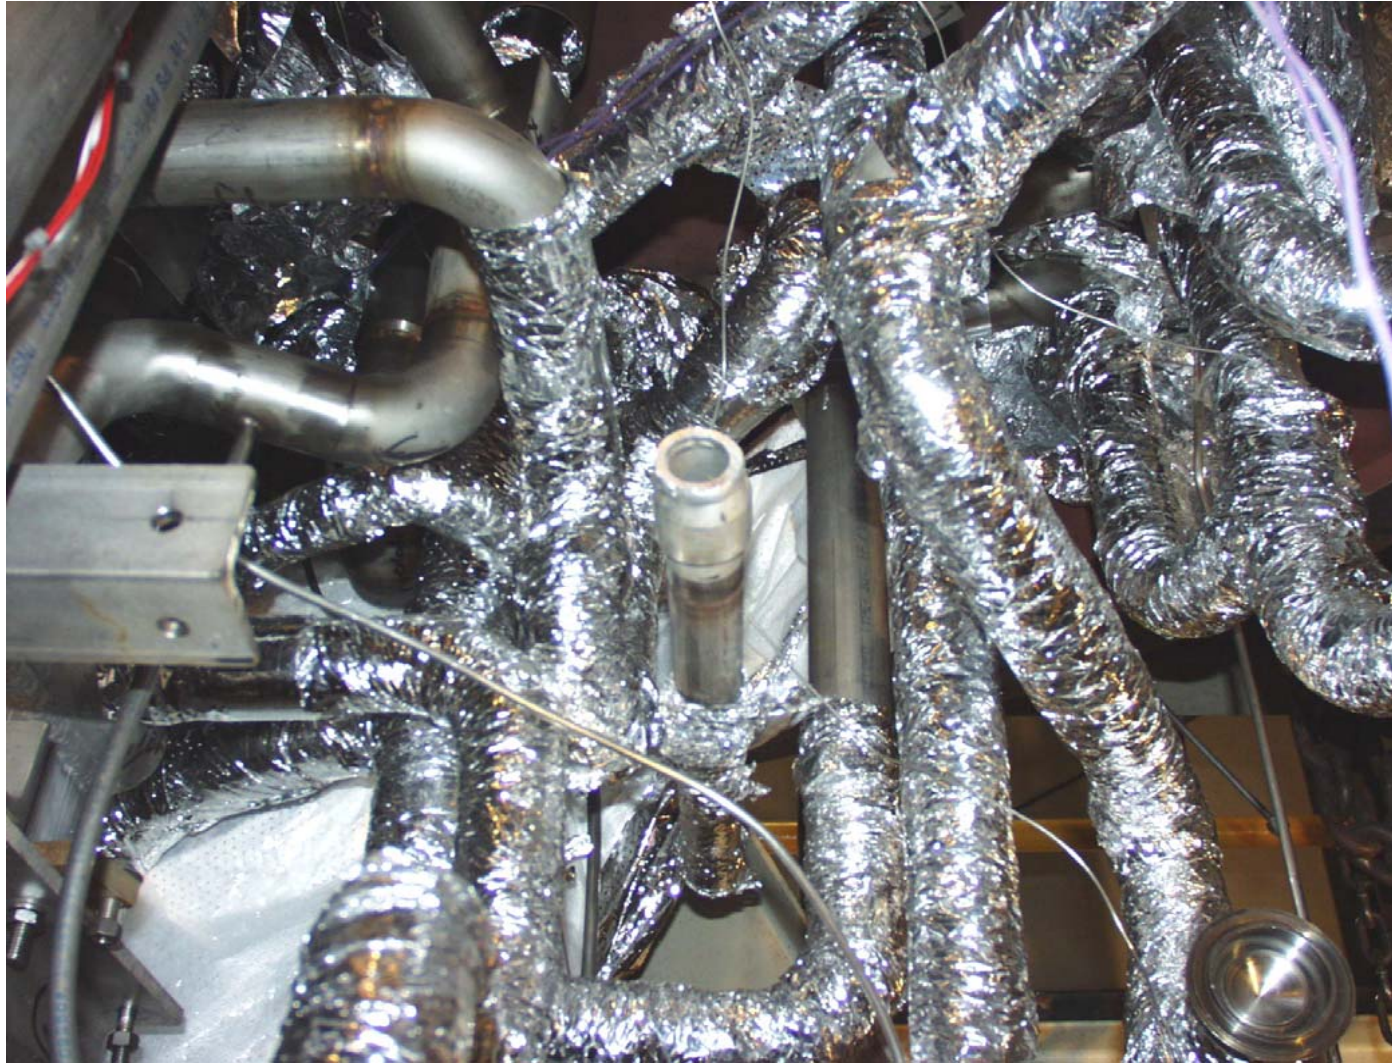
D.2) Pipe preparation LN2 outlet.

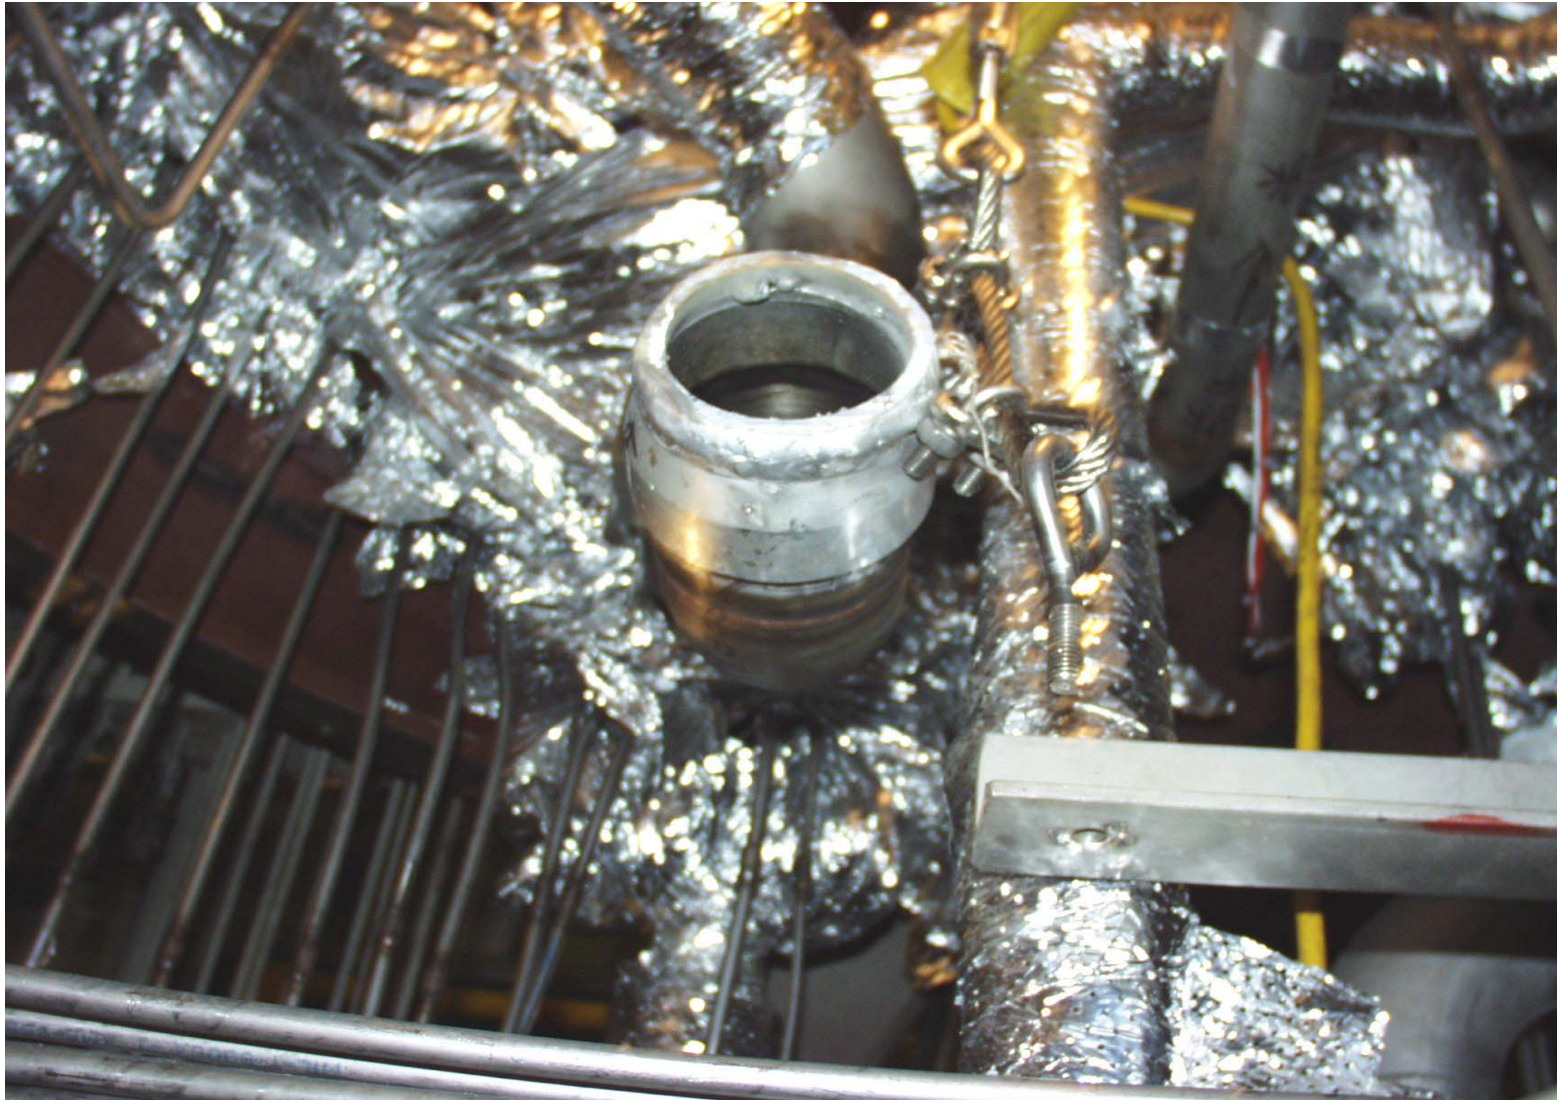
D.3) Pipe preparation high pressure inlet.

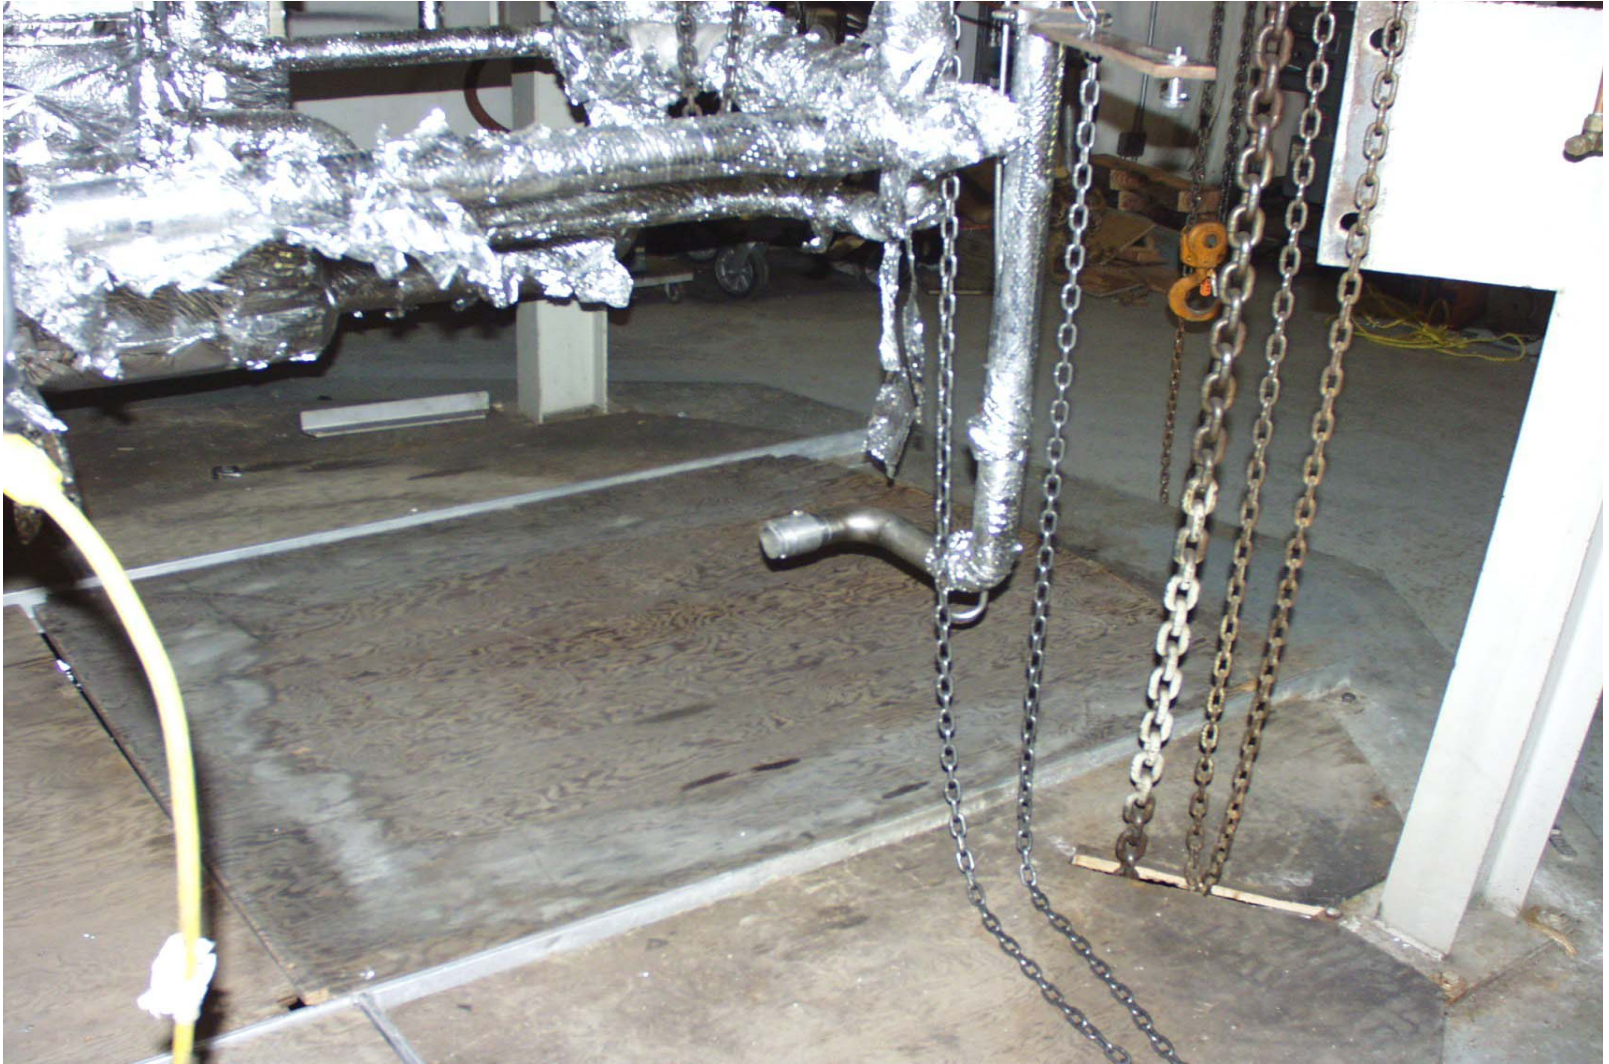
D.4) Pipe preparation high pressure outlet.

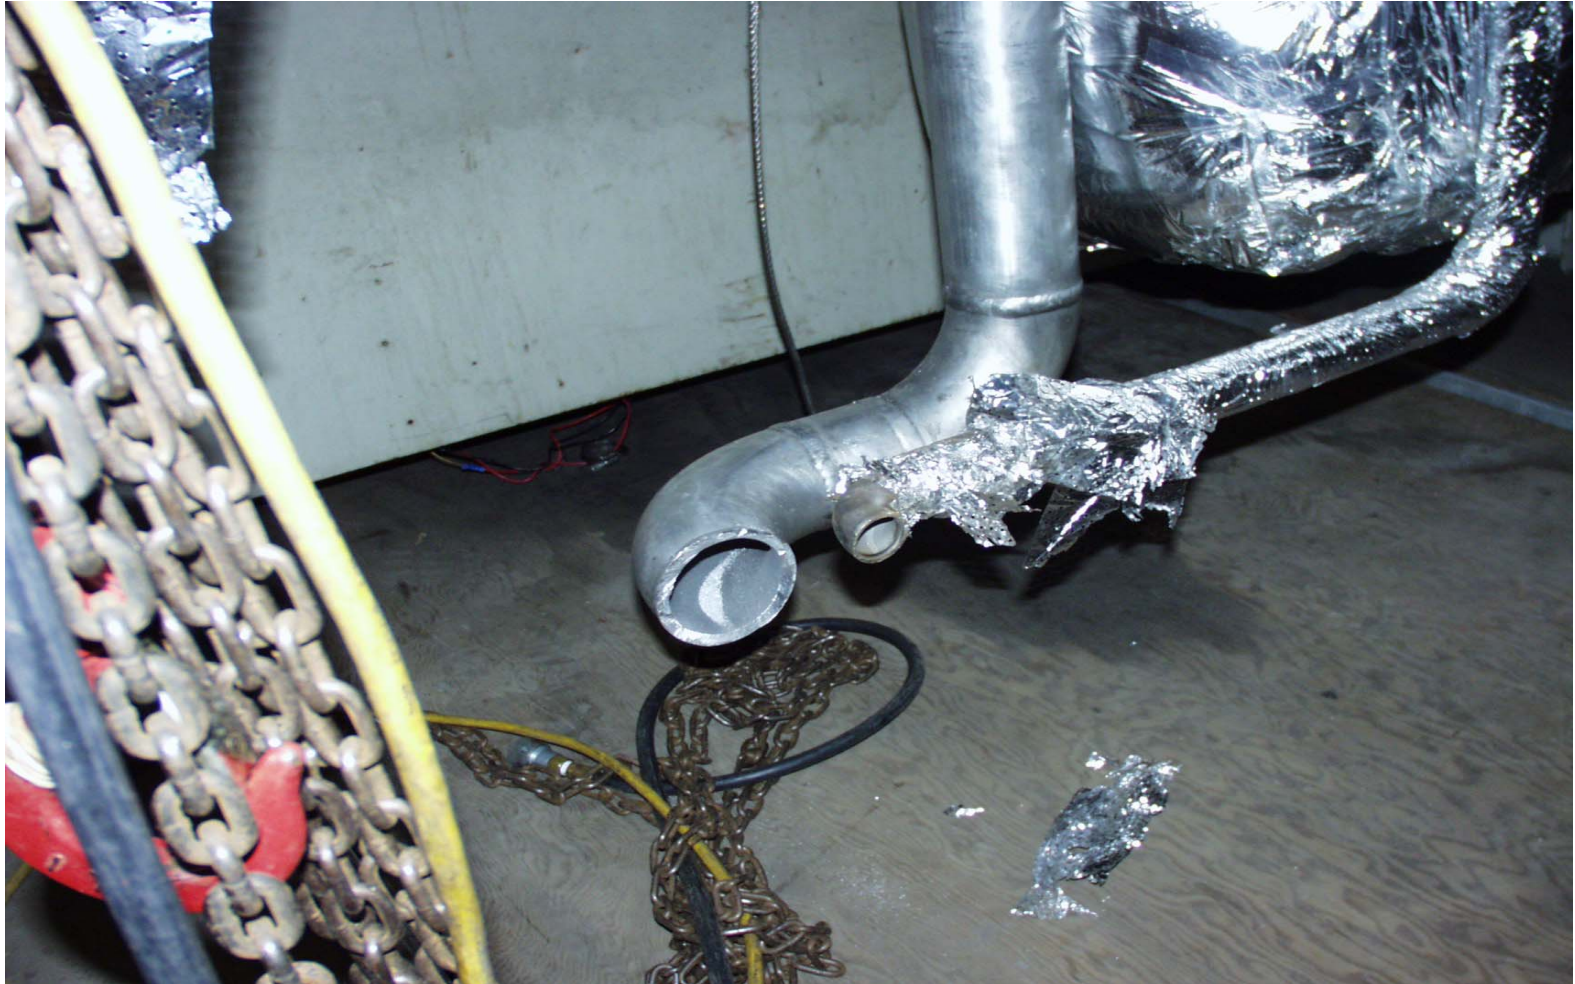
D.5) Pipe preparation low pressure inlet and LN2 inlet.

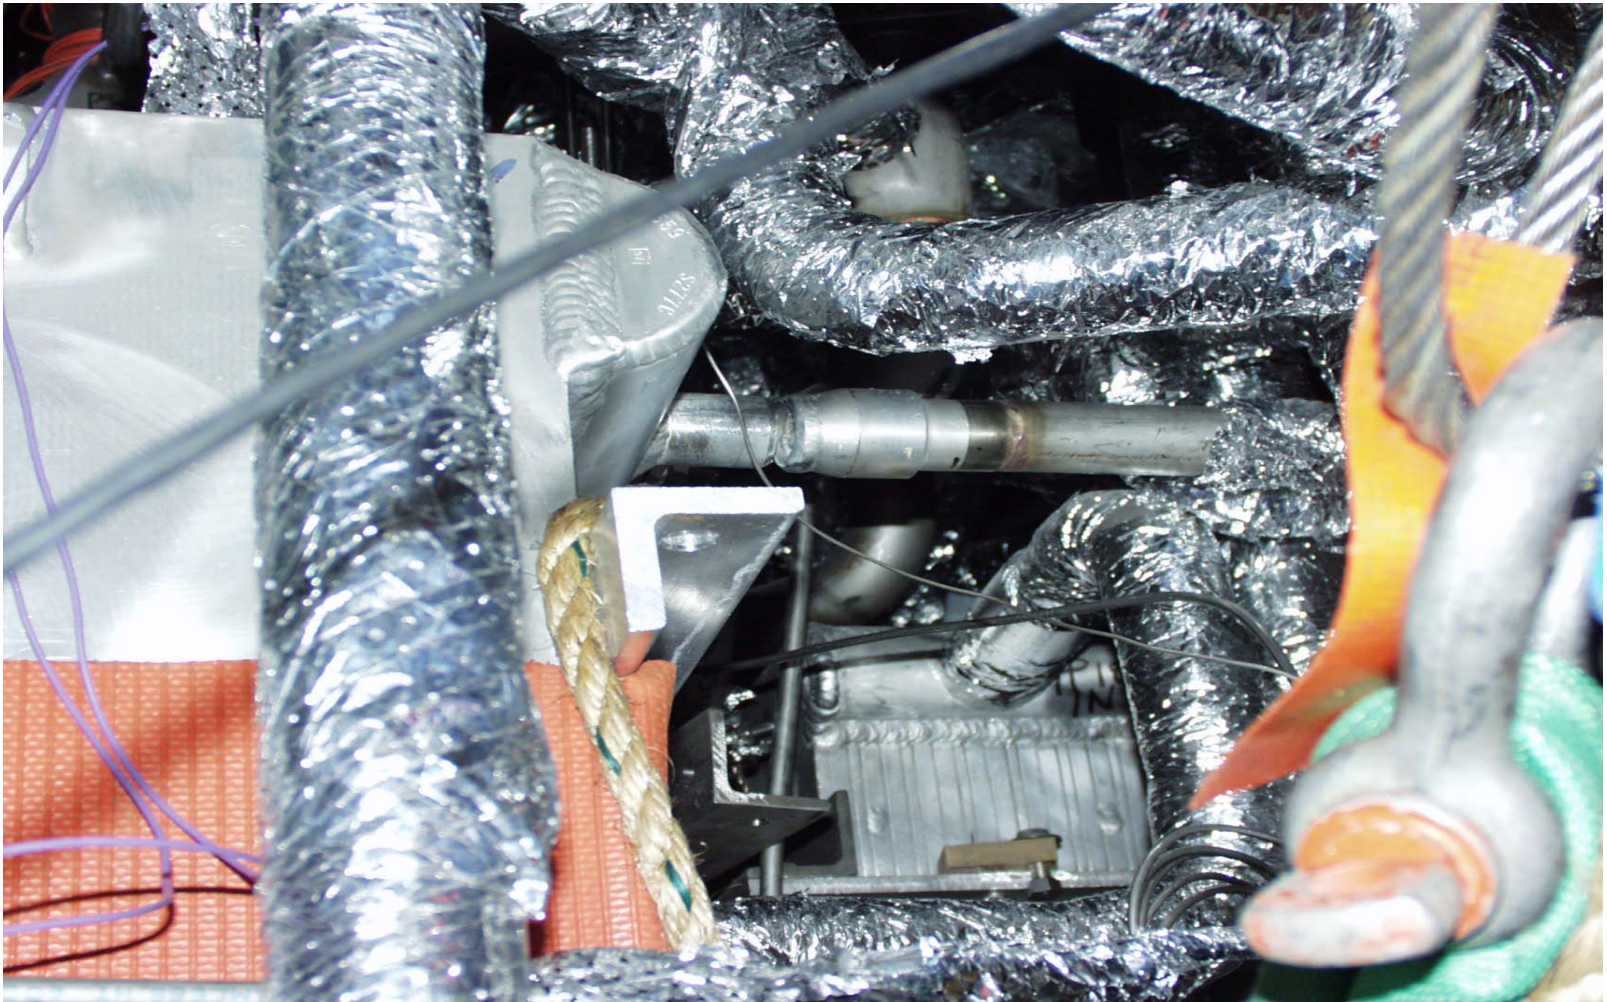
E.1) New heat exchanger installed (LN2 outlet.)

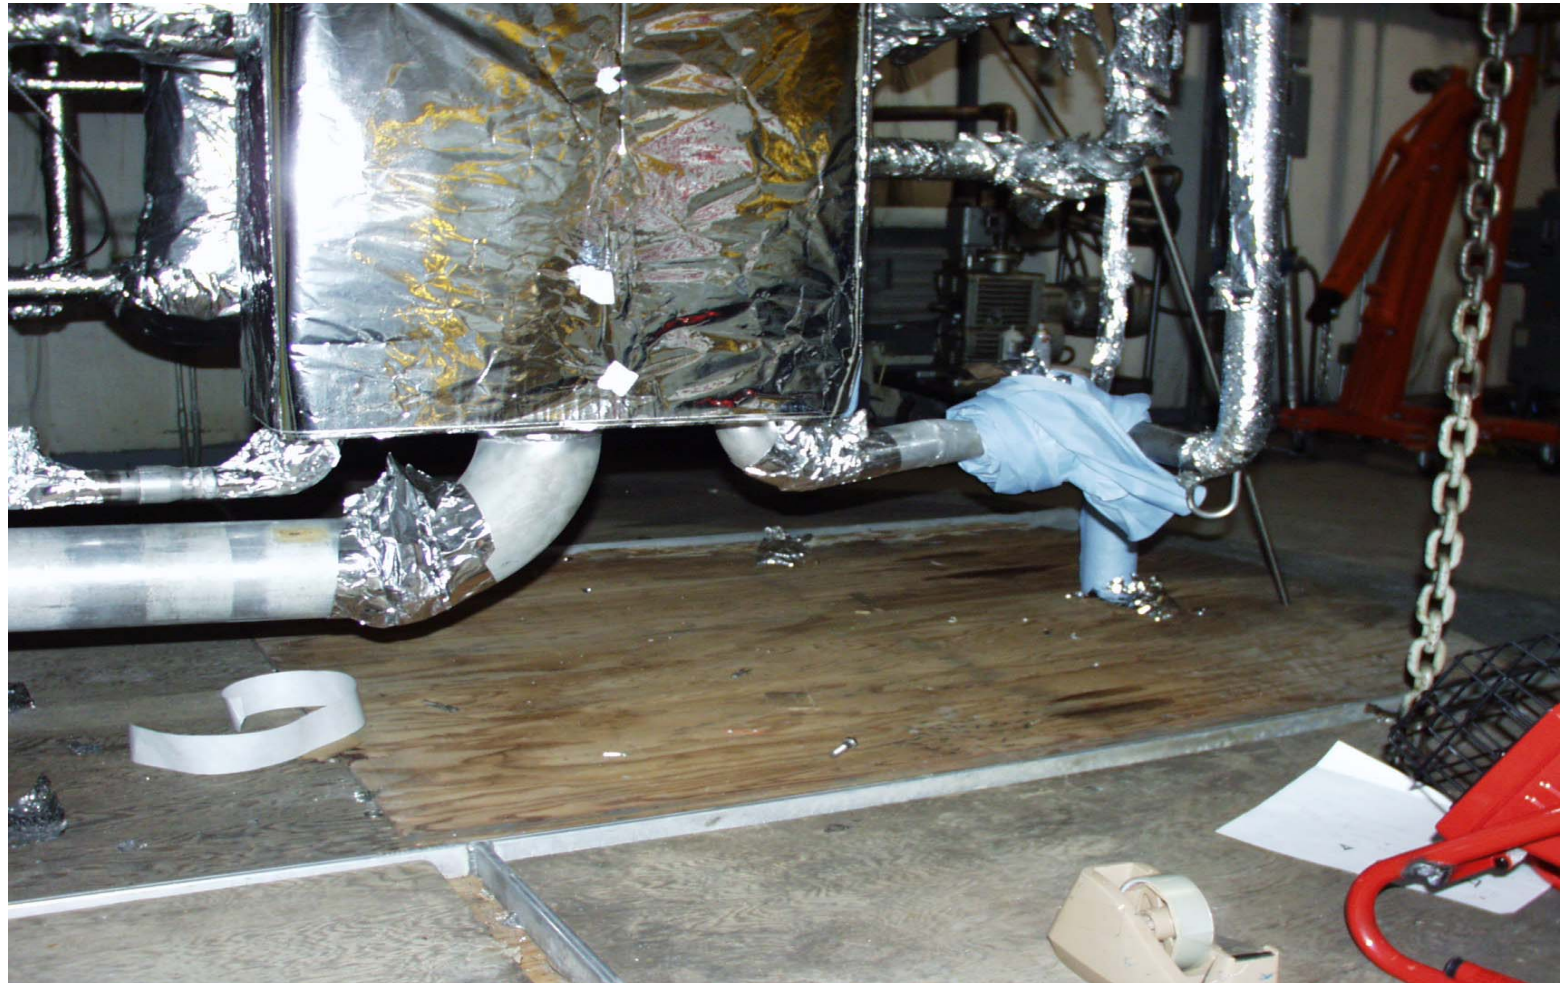
E.2) New heat exchanger high pressure outlet, low pressure inlet and LN2 inlet.

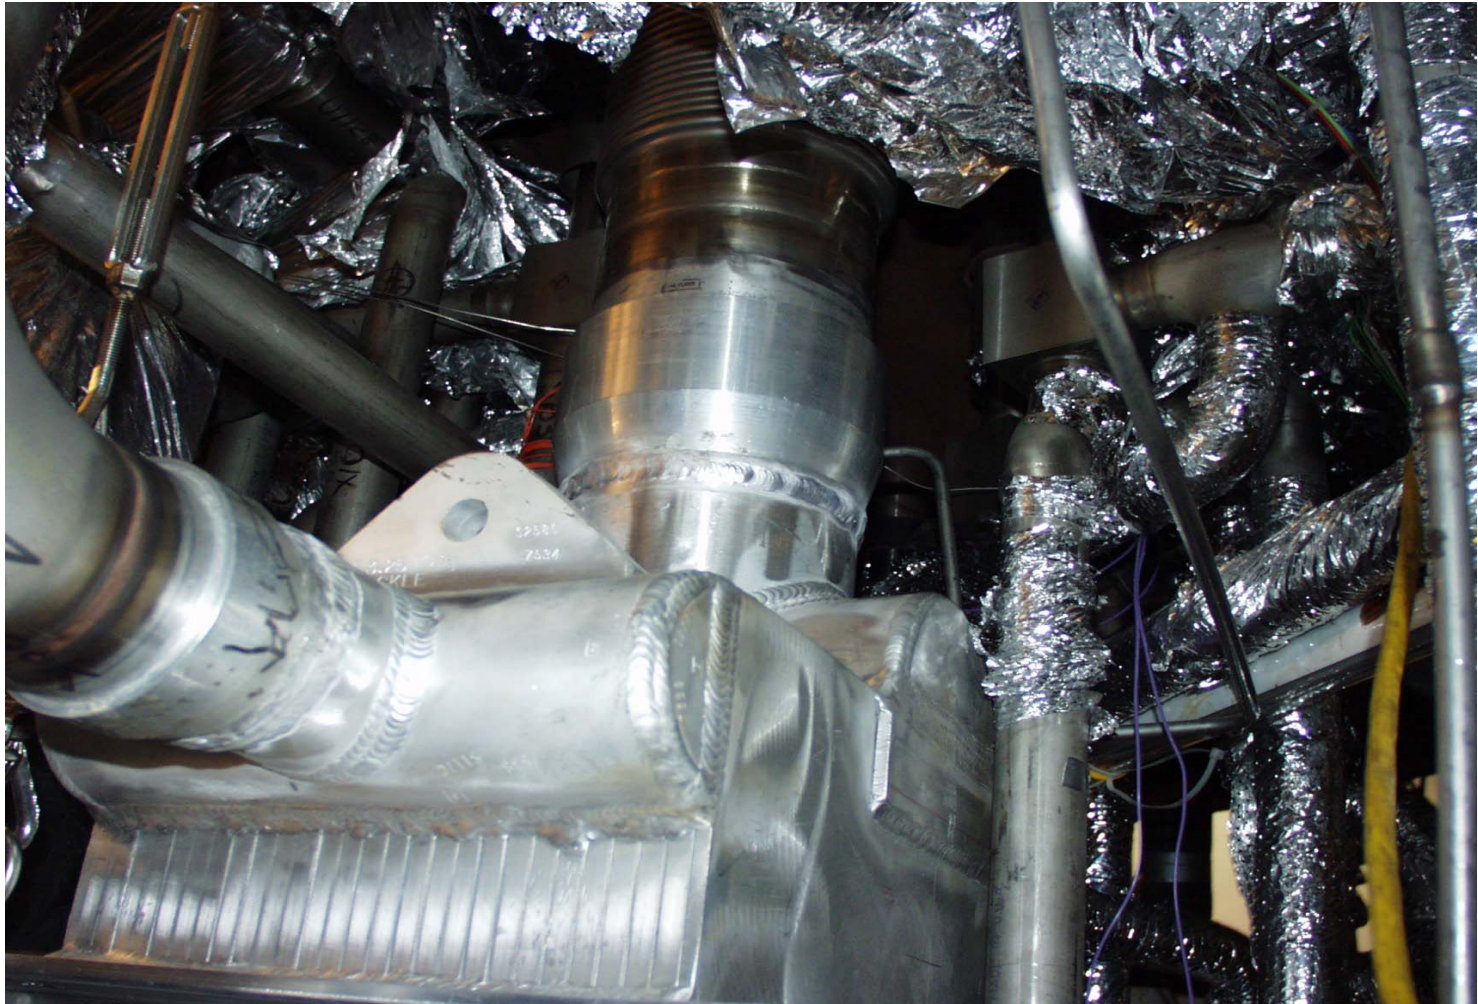
E.3) New heat exchanger high pressure inlet, low pressure outlet.

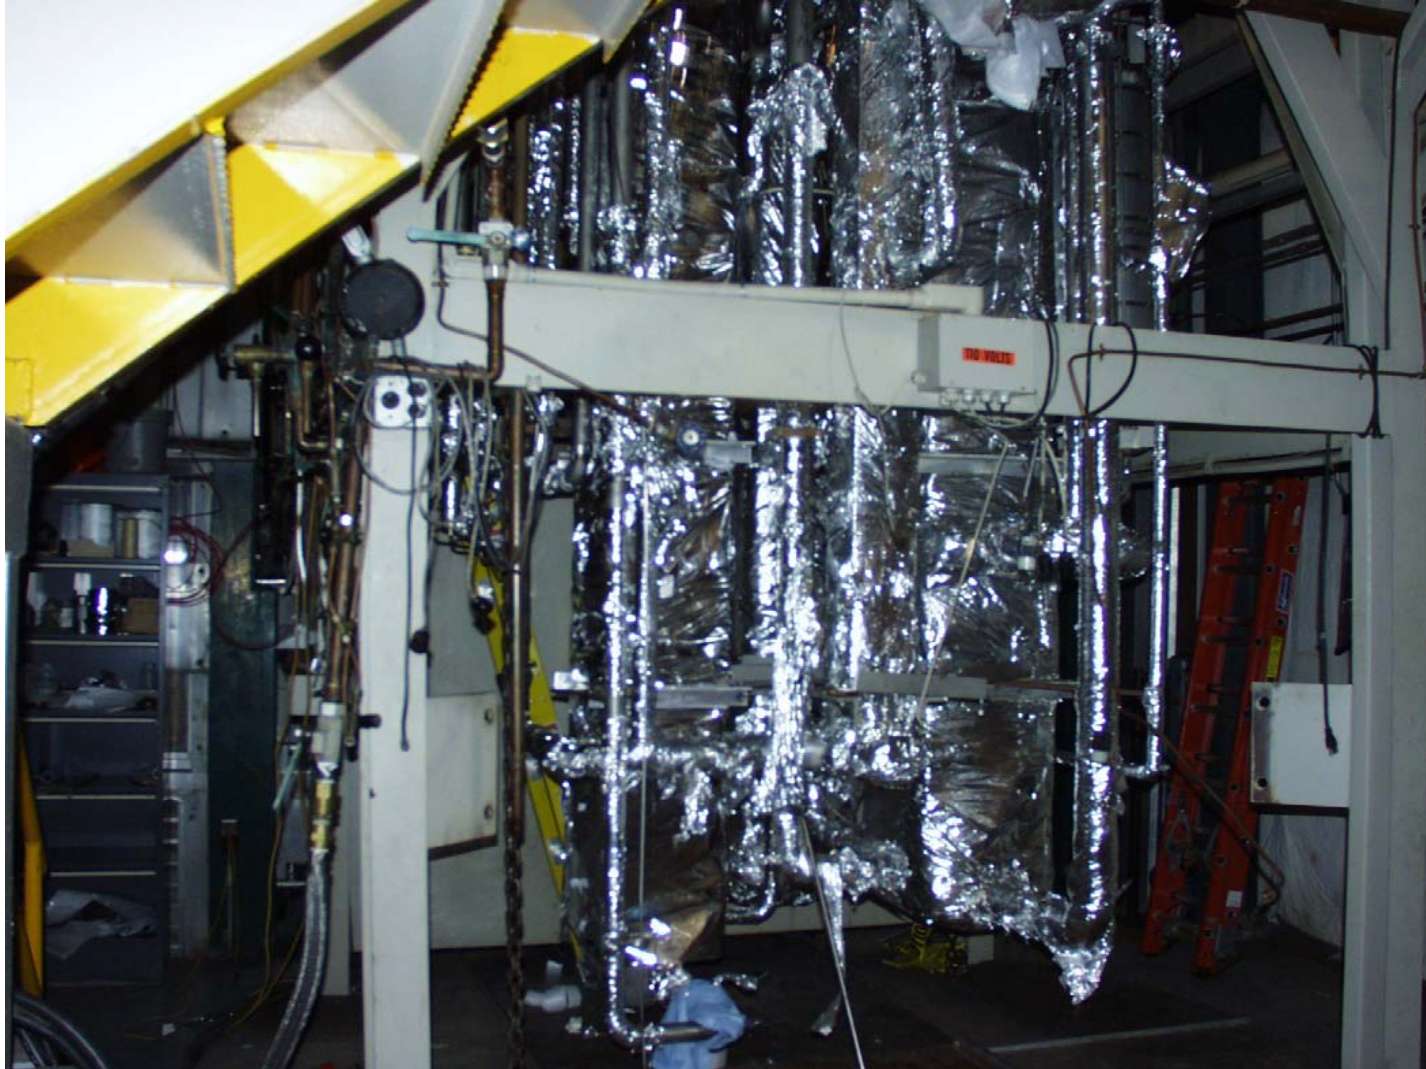
E.4) New heat exchanger insulated.

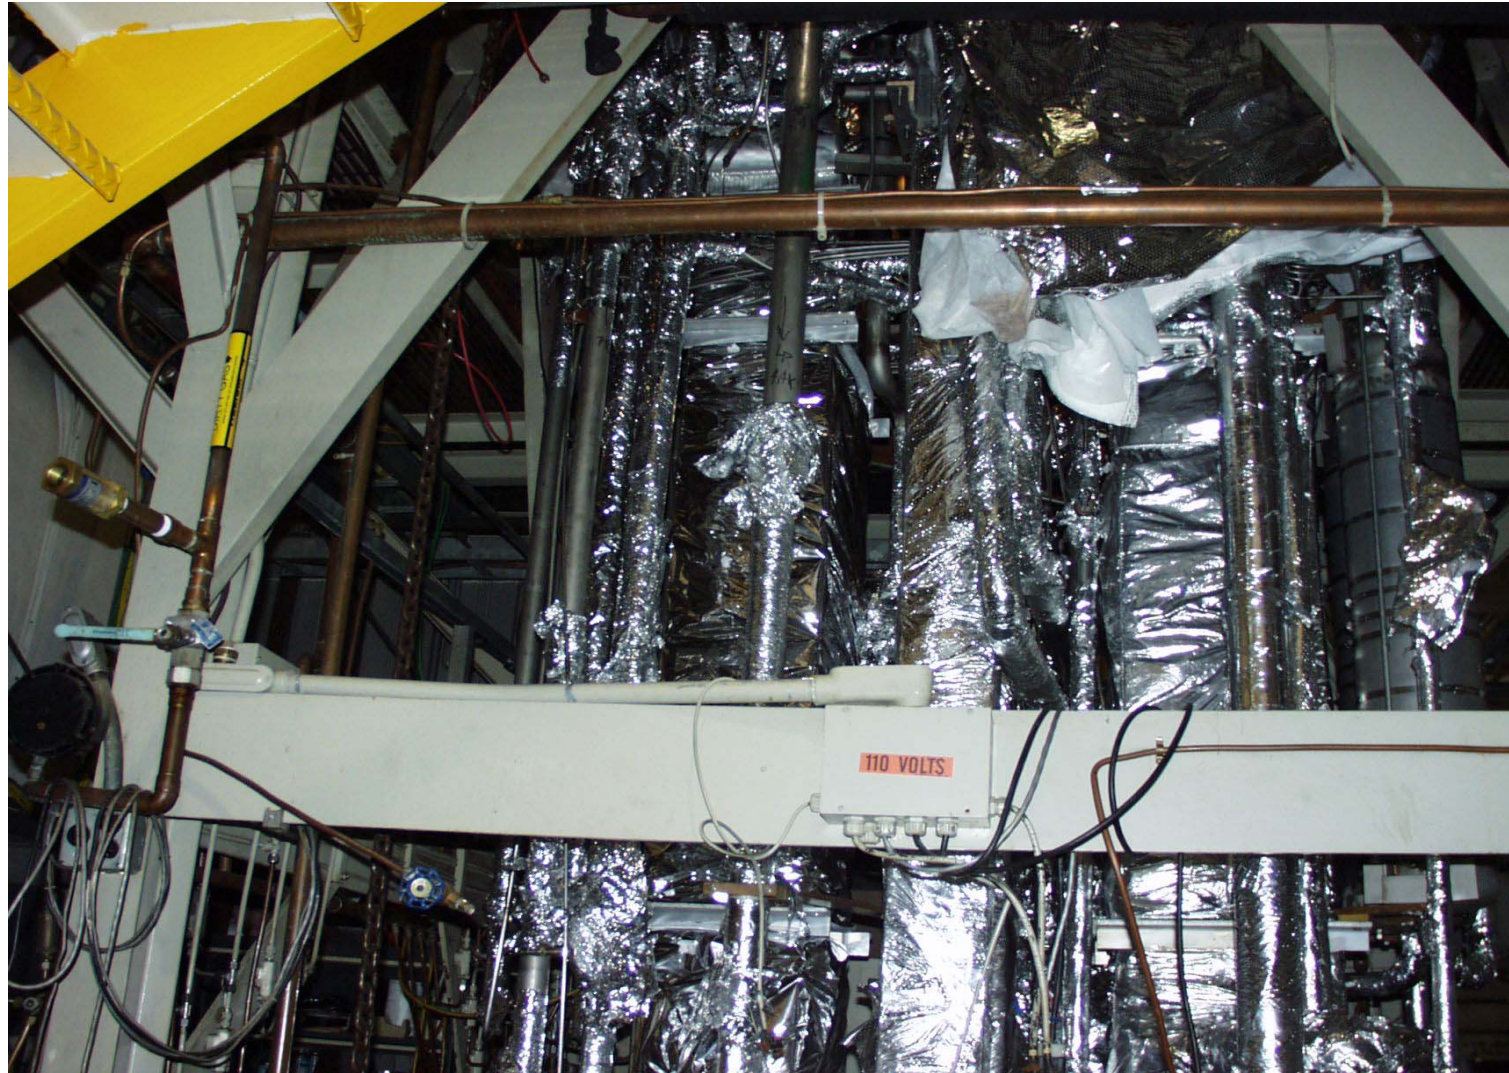
E.5) New heat exchanger insulated.
